Dive Conditions: Update # 13

## *Pool Diving Injection Molded NEMO 1*

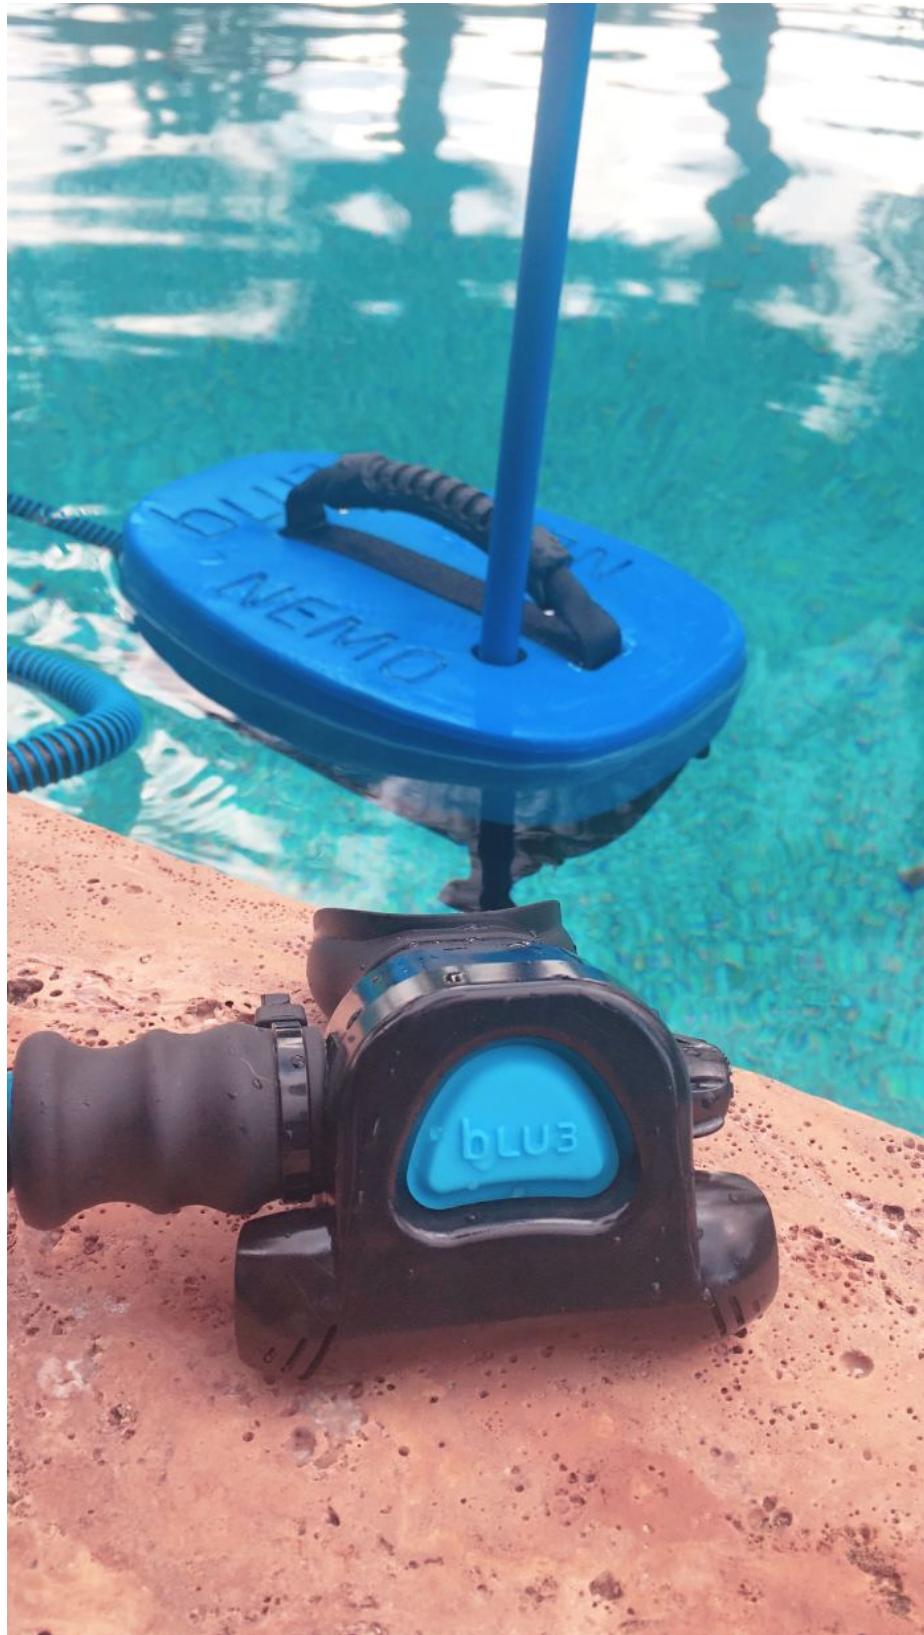
**Report:** We are happy to share that NEMO's first injection molded dive went extremely well. While some changes to molded parts need to be completed before finalizing the molds for production, the overall design is in great condition. Performance is better than ever, the parts look beautiful, and NEMO feels more like a final product than it ever has before.

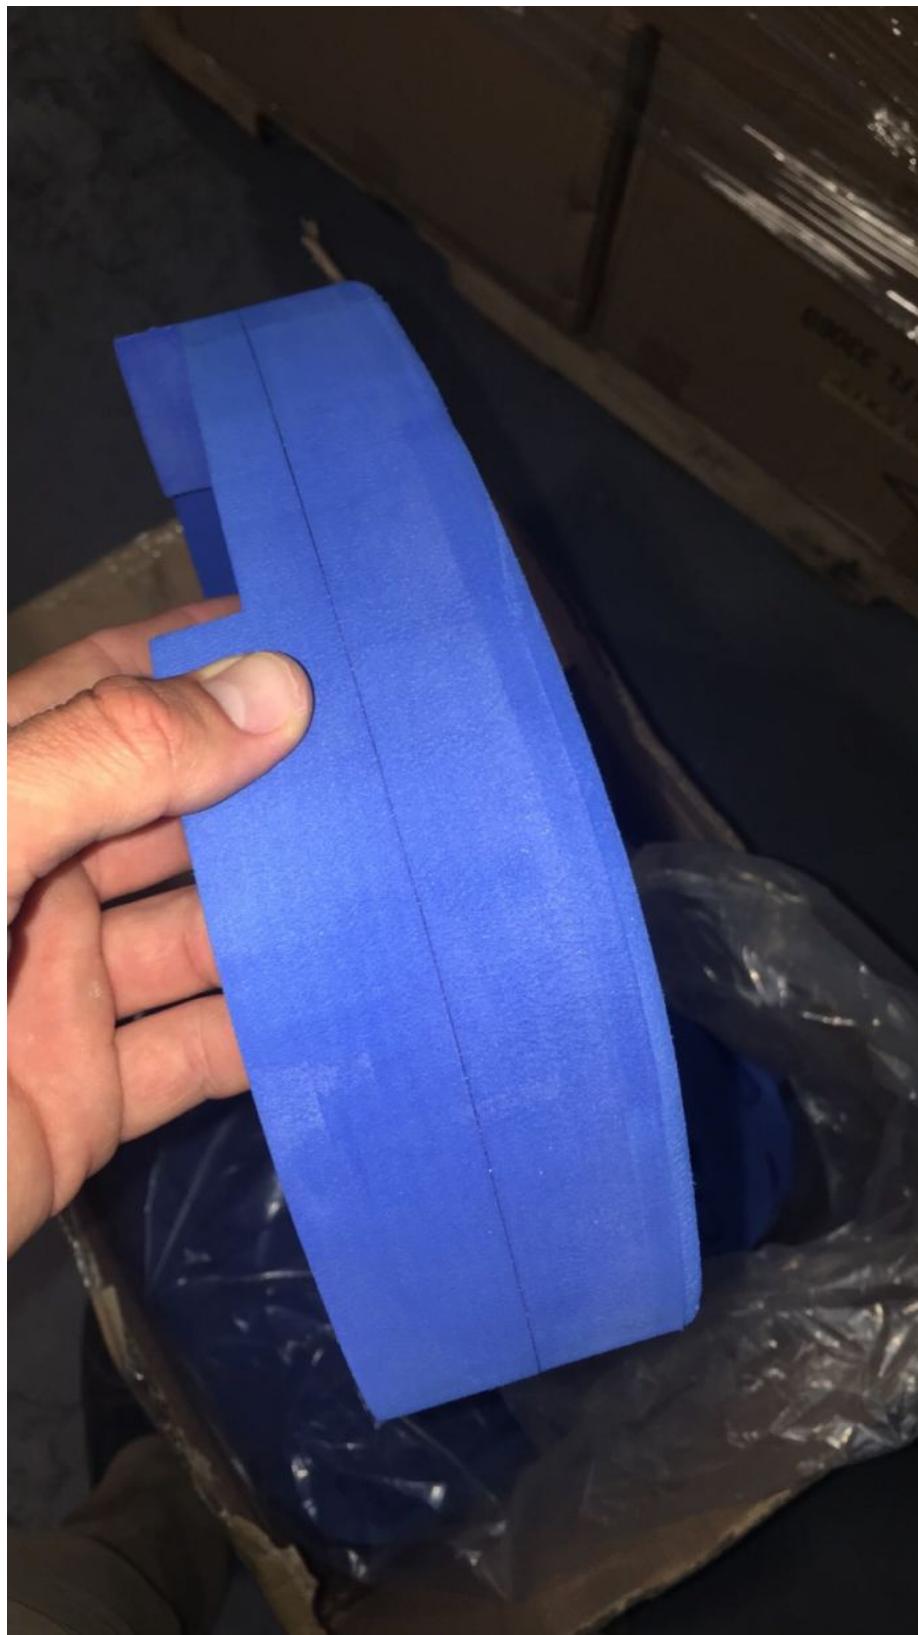
We came across our first major part defect last week when we received our initial delivery of foam flotation units. Through the prototyping process of this part, the manufacturer built it out of two pieces glued together. We found that this method worked fine for prototyping, but the units were not durable enough to be used in the final product. For this reason, we specified with the manufacturer that the production units must all be built from one foam block and not two pieces glued together.

As it turns out, the manufacturer realized that they did not have the correct thickness of foam sheets and it would be an extra step in their process to source the sheets, so they decided to build the first production run with two pieces glued together anyway. When we opened one of the boxes upon delivery after 45 days of shipping by sea, we were devastated to find that the manufacturer had ignored our specification. It is especially frustrating to find such a simple mistake amidst so many other complex designs that are moving along smoothly.

## *Foam Flotation Unit Defect*

Fortunately, we had specified in writing that the parts must be built out of one block of foam, and the manufacturer is making right by building a new production run and shipping us enough units by air at no cost to BLU3. They will keep more parts on standby in case we need additional foam flotation units on short notice.
