**Report:** We are happy to share that NEMO's first injection molded dive went extremely well. While some changes to molded parts need to be completed before finalizing the molds for production, the overall design is in great condition. Performance is better than ever, the parts look beautiful, and NEMO feels more like a final product than it ever has before.

### *Pool Diving Injection Molded NEMO 1*

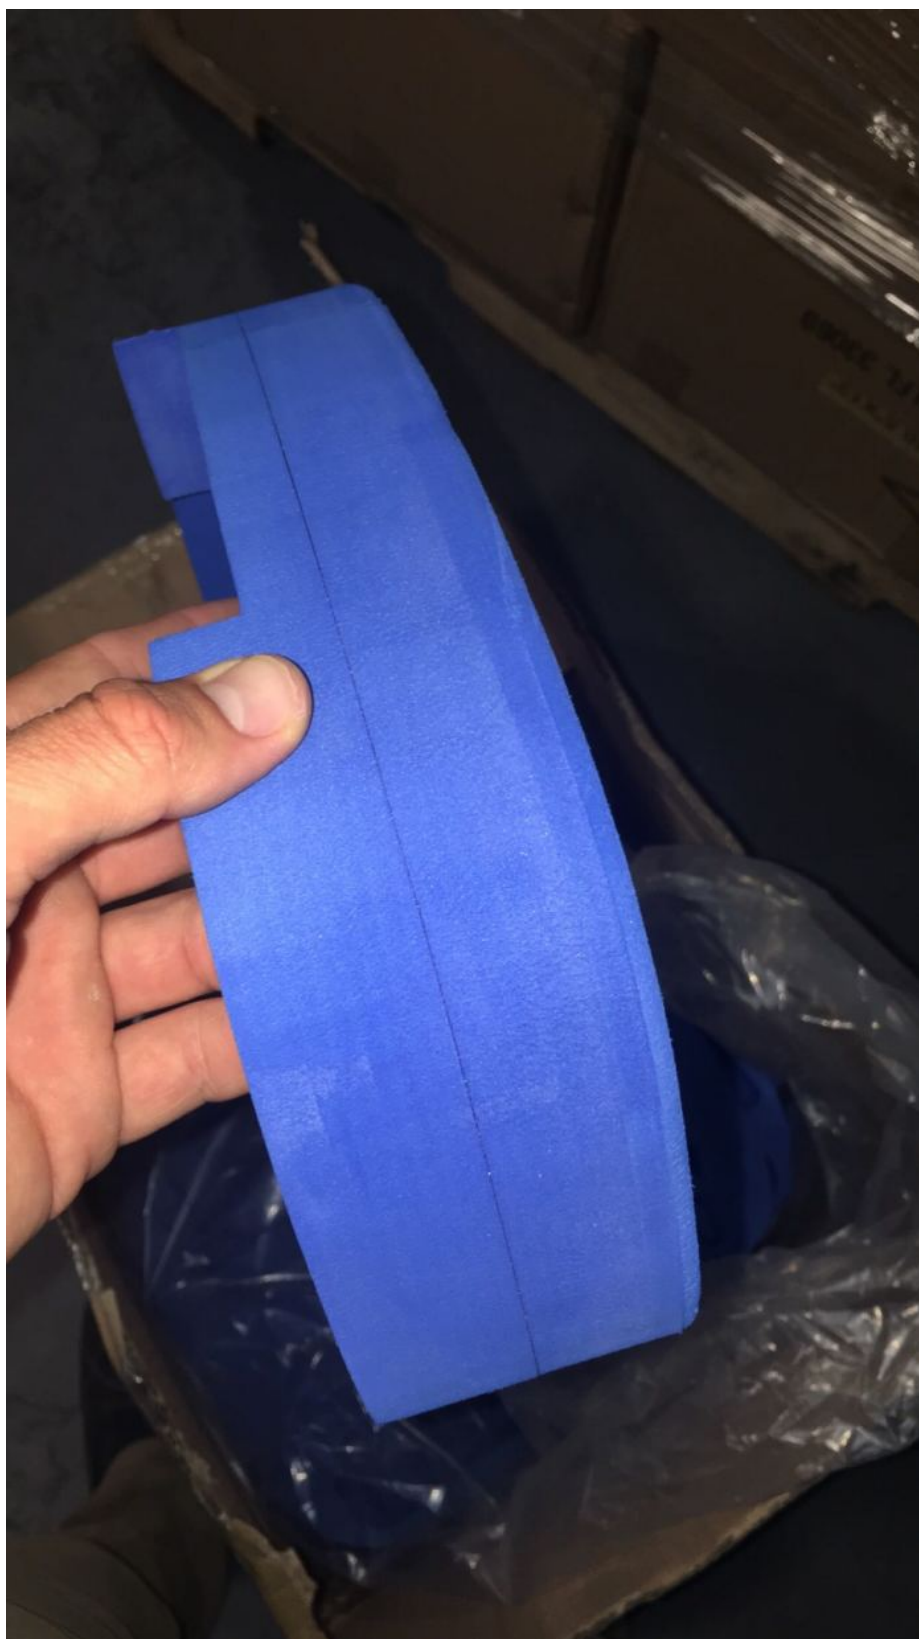
We came across our first major part defect last week when we received our initial delivery of foam flotation units. Through the prototyping process of this part, the manufacturer built it out of two pieces glued together. We found that this method worked fine for prototyping, but the units were not durable enough to be used in the final product. For this reason, we specified with the manufacturer that the production units must all be built from one foam block and not two pieces glued together.

As it turns out, the manufacturer realized that they did not have the correct thickness of foam sheets and it would be an extra step in their process to source the sheets, so they decided to build the first production run with two pieces glued together anyway. When we opened one of the boxes upon delivery after 45 days of shipping by sea, we were devastated to find that the manufacturer had ignored our specification. It is especially frustrating to find such a simple mistake amidst so many other complex designs that are moving along smoothly.

### *Foam Flotation Unit Defect*

Fortunately, we had specified in writing that the parts must be built out of one block of foam, and the manufacturer is making right by building a new production run and shipping us enough units by air at no cost to BLU3. They will keep more parts on standby in case we need additional foam flotation units on short notice.
