Dive Conditions: Update # 13

Pool Diving Injection Molded NEMO 1

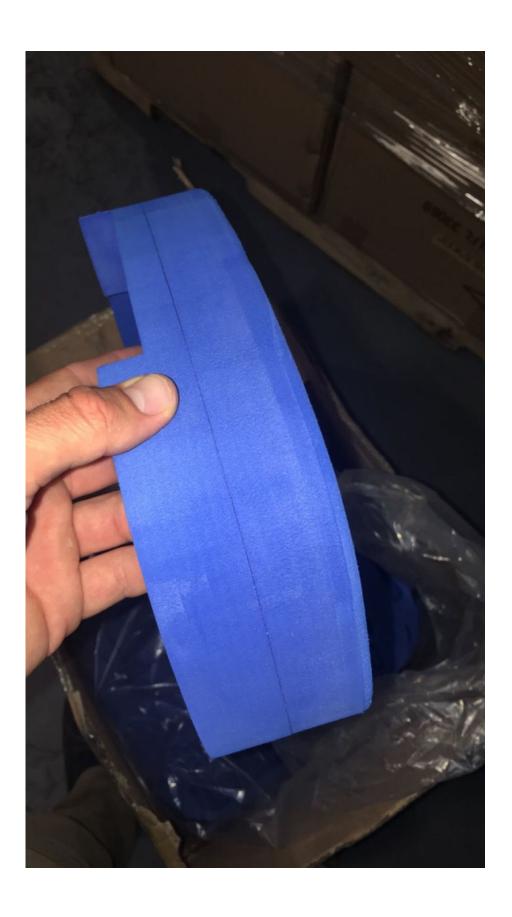
Foam Flotation Unit Defect

We came across our first major part defect last week when we received our initial delivery of foam flotation units. Through the prototyping process of this part, the manufacturer built it out of two pieces glued together. We found that this method worked fine for prototyping, but the units were not durable enough to be used in the final product. For this reason, we specified with the manufacturer that the production units must all be built from one foam block and not two pieces glued together.

As it turns out, the manufacturer realized that they did not have the correct thickness of foam sheets and it would be an extra step in their process to source the sheets, so they decided to build the first production run with two pieces glued together anyway. When we opened one of the boxes upon delivery after 45 days of shipping by sea, we were devastated to find that the manufacturer had ignored our specification. It is especially frustrating to find such a simple mistake amidst so many other complex designs that are moving along smoothly.

Fortunately, we had specified in writing that the parts must be built out of one block of foam, and the manufacturer is making right by building a new production run and shipping us enough units by air at no cost to BLU3. They will keep more parts on standby in case we need additional foam flotation units on short notice.
